24 June 2021

# A Tale of Two Hubcaps

by Haakon MacCallum  
member of Detroit Committee  
Vancouver Electric Vehicle Association

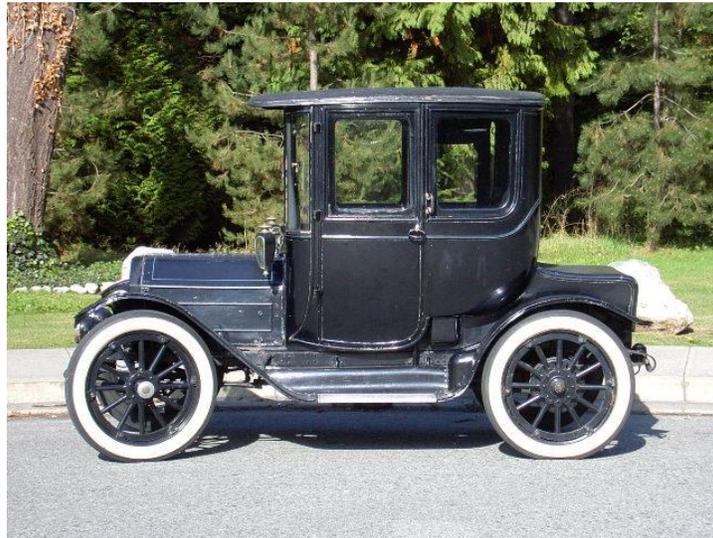
*Figure 1: VEVA's Detroit - Where are the Hubcaps?*

Your author has only ever known VEVA's Detroit to have two hubcaps – one of each front wheel. However, pictures from further back in history show our car sporting all four hub caps. Thanks to the Covid-19 shutdown VEVA finally had the opportunity to correct this deficiency and restore our Detroit to its former, four hubcap glory.

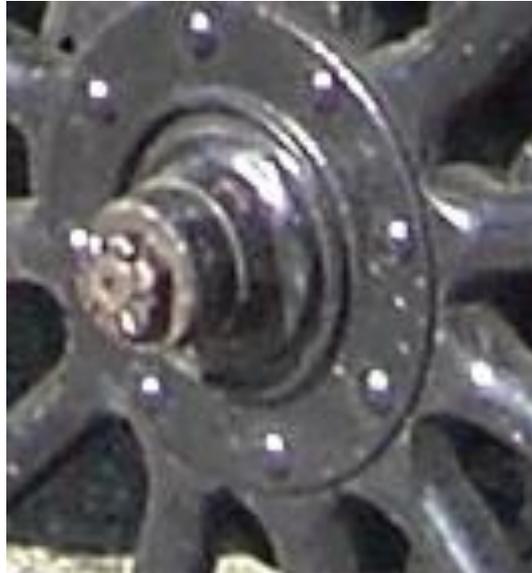
A cursory inspection of the car showed that the hubs on the front wheels have the normal threads for the hubcaps ( $2\frac{3}{4}$ ” - 16), but the rears did not. A closer inspection of the rear hubs showed that the threads looked to have been crudely ground off at some point in the past. One can also tell that the hubs are not original since the original holes to affix the brake drums do not line up with those of the hubs.

*Figure 4: Rear Hubs Without Threads*

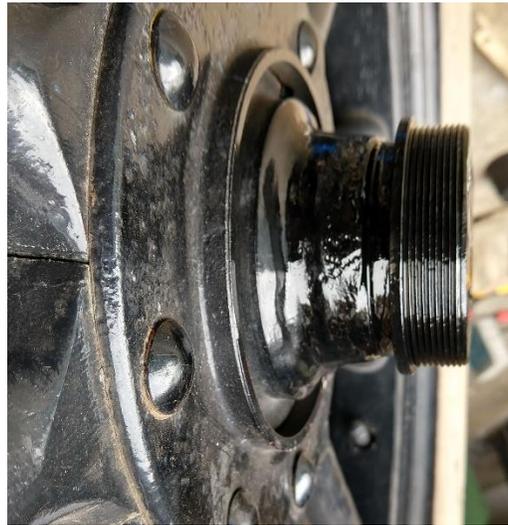
*Figure 5: An Adapter Ring Welded to the Hub Restores the Threads*

Many thanks to Jack for the idea of making a ring to put on the hubs as an adapter. Many hours, piles of shavings, a few orders for turning tools, and a chunk of steel later along with an inexpensive Craigslist lathe and the rings were finished. These were welded to the hubs and the finished product looks authentic enough.

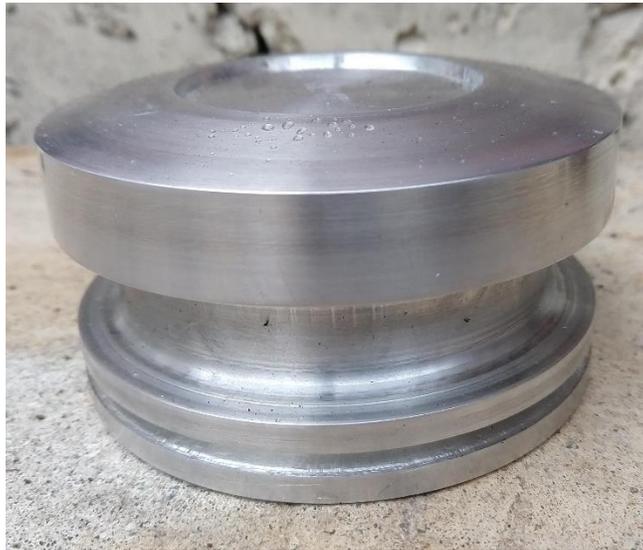
The next problem to overcome was a missing hubcap. VEVA only had three. Again, it was time to pull out the Craigslist lathe and start turning.

*Figure 7: An Imitation Detroit Hubcap Taking Shape*

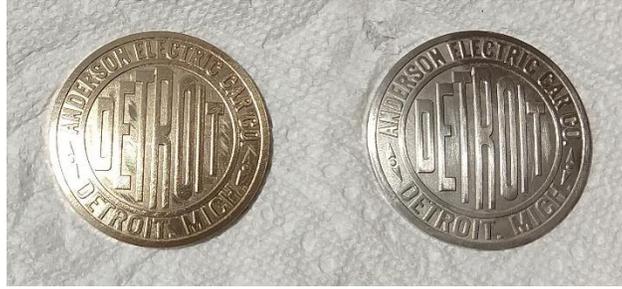
*Figure 11: Replacement Nameplate in Shown in Brass and with Nickel Plate*

Once the turning was done, the nameplate was next. A later version of the nameplate is shown nicely in drawing 35761 (many thanks to [electricvehiclemuseum.org](http://electricvehiclemuseum.org) and Galen Handy), though the ones on VEVA's car still have the Anderson Car Co. text. The nameplate was drawn in CAD and sent for manufacture. The original nameplate was likely stamped, but the replacement is made with CNC.

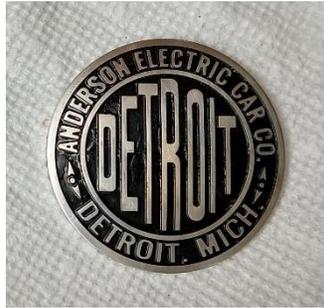
*Figure 12: Replacement Hubcap Nameplate*

Once cleaned, the new nameplate is nickel plated and then the valleys filled with black paint, as specified in drawing 35761.

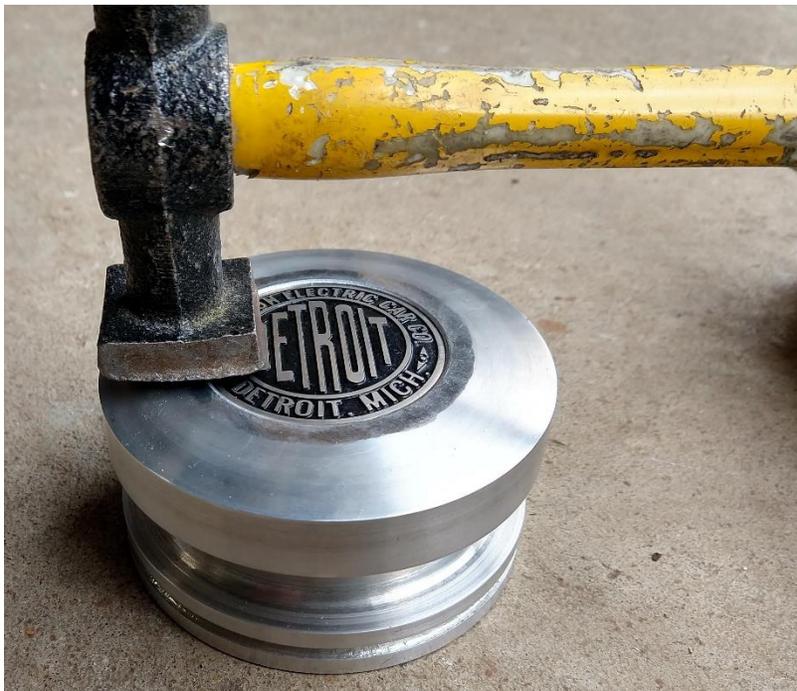
Figure 14: Installing Nameplate in Hubcap

According to drawing 22351 the nameplate is installed by spinning the edge of the aluminum over the nameplate. Instead, the edge was hammered over and then the finished surface re-machined to make a smooth finish.

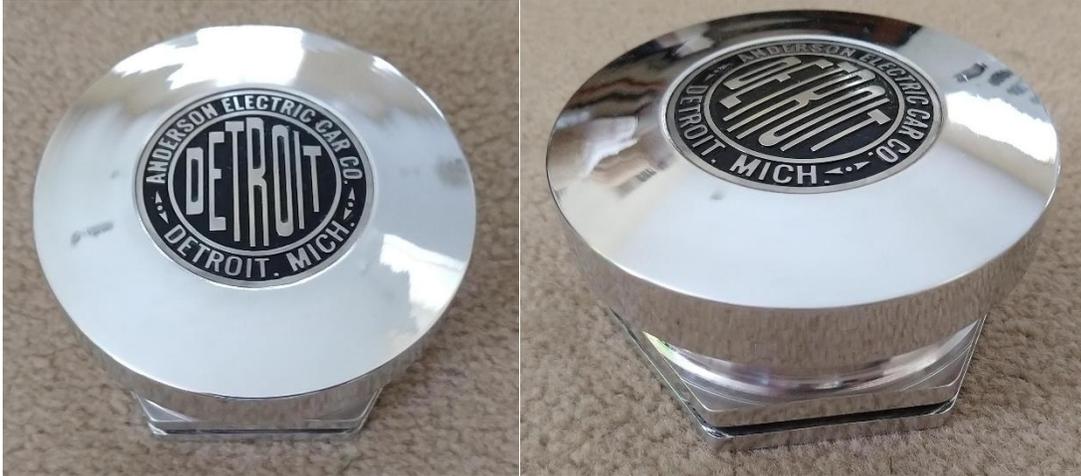
*Figure 15: Finished Hubcap*

After the nameplate was installed, there was no more lathe work required, so the six sides of the hex nut could be cut. The sides of the hex nut were first cut using a bandsaw and finished with a sander. Some time on the buffing wheel gave the final product.

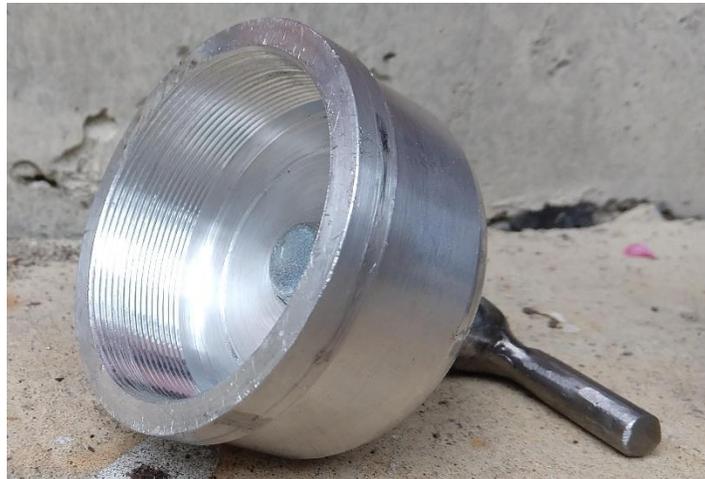
*Figure 16: A New Wheel Puller*

As a final touch to the project, VEVA also made a wheel puller. Up to this time, removing the wheels has always been a puzzle – though your author found that a tap with a 2 lb sledge against the inside edge of the brake drums did the job best. We are also careful not to tighten the wheels too tightly. Now that the threads on the hubs are restored, a proper wheel puller would again work. The same refrain on the lathe and a puller came to life. Because it is so much easier to machine, the puller was from aluminum rather than the customary steel. It works well, but it will be interesting to see how long it lasts.
