(Imitation) Radiator Repair Project

Haakon MacCallum

Vancouver Electric Vehicle Association

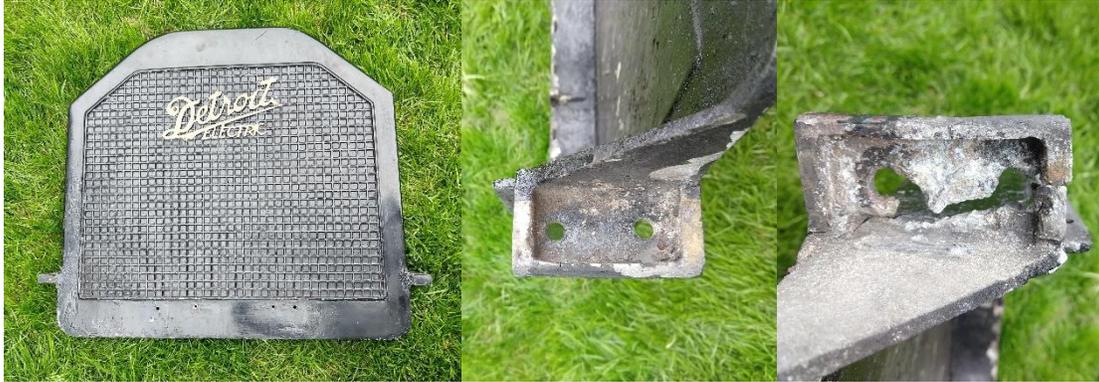
The imitation radiator on VEVA's car is mounted with two flanges, cast on each side of the radiator. Two bolts through each flange affix the radiator to the chassis. After 100 years the flanges had cracked and started to separate from the main casting. There is evidence that the flanges had been somewhat unsuccessfully repaired in the past as well.

Figure 2: Cracking Flanges

Anderson drawing 4178 of the radiator (again our thanks to electricvehiclemuseum.org and Galen Handy) specifies it is made from aluminum. However, prior to WW1, there was no standard for exactly what aluminum might be. Apparently, the mix could change from morning to night as the shifts changed and each craftsman used their own special concoction. Your author suspects that casting such a large part from aluminum was difficult – judging from the number of cracks in the part. Alloying the aluminum would have helped to reduce the number of part failures at the time of manufacture.

At some point a repair had been attempted with some kind of welding process, but the weld was of poor quality and likely never really worked.

Aluminum brazing was chosen as the successful repair method. Blue Demon BDTP-125-01T low temperature aluminum-zinc brazing rod worked well on the radiator material. The tensile strength of the rod is 47,000 lb/sq in and the Brinell hardness is 100 – which is very similar to 6061 aluminum – and likely stronger than the original material the grille is made from. Bernzomatic AL3 Aluminum Brazing/Welding Rods also worked well, but its tensile strength was not quite as high and it was slightly more expensive.

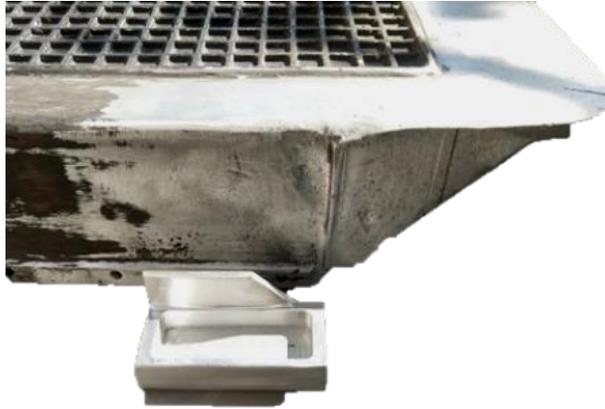
Figure 3: Replacement Flange Before

The flange with the worst damage was cut off and a replacement flange was made to replace it. The flange was created via CNC, and then shaped by hand to match the grille. On the replacement flange, an extra wall was created on the grille side to allow plenty of area for the brazing material to bond.

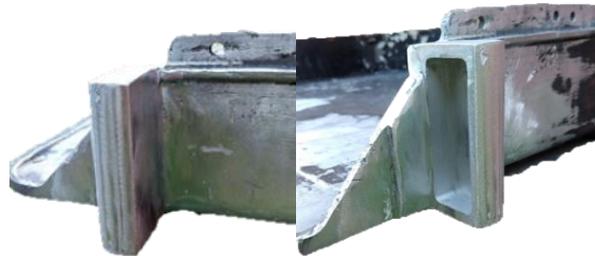
Figure 4: Replacement Flange After

To attach the replacement flange, the mating surfaces are covered with the brazing rod material, and then the replacement flange placed on top. To affect the bond the two parts are then heated to re-melt the brazing material in between the parts. Once the parts are attached, the brazing material can be used as a filler to affect the required fillets around the flange.

The flange on the other side needed only the corrosion and material from the previous repair removed, and then the brazing rod material could be used as a filler material. The brazing rod material has a high surface tension and therefore can be made quite thick before it runs off. Because the orientation of the grille was never perfect, large blobs would accumulate in some areas during the brazing process, which resulting in a great deal of grinding. Good welders weld, poor welders grind, apparently.

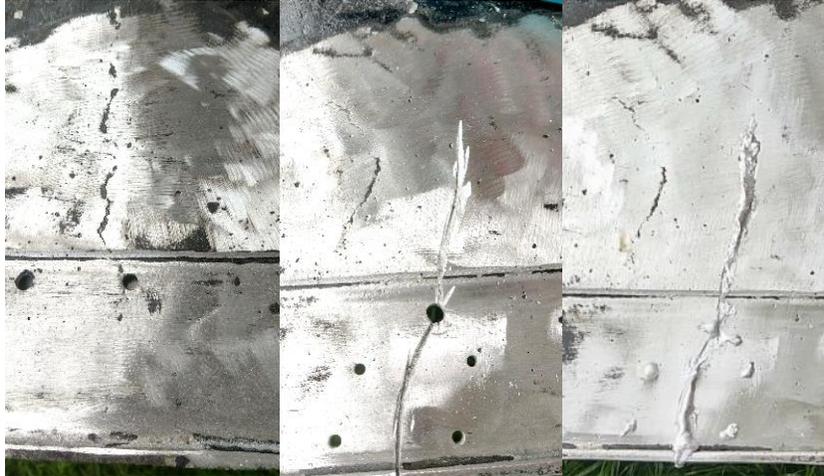
Figure 5: Cracks Are Cleaned, Ground, Repaired and Ground Again

In the interior of the grille there were two large cracks and a number of holes that required repair. The cracks were ground out and filled with the brazing rod material with reasonable success. The size of the part made it difficult to apply enough heat – so two high-heat propane torches were used. The cracks went through many of these holes, and therefore, the holes were filled at the same time. The front side is ground flush, and the back side is ground nearly flat. Because it was difficult to fill every crack and hole perfectly with the brazing rod, JB Weld, a metal filled epoxy was used as a filler to finish off the surfaces.

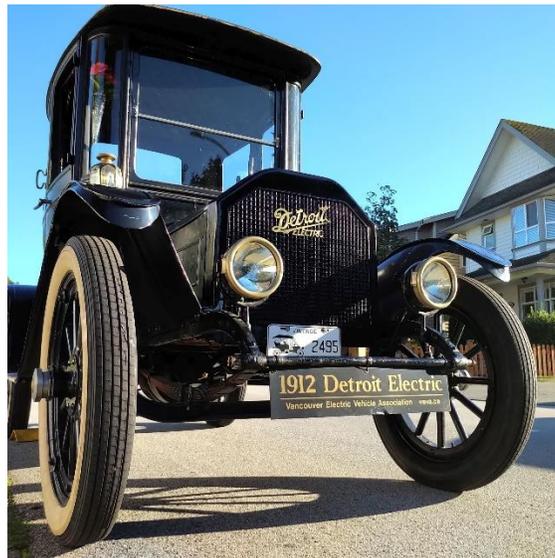
Figure 6: The Finished Grille

Finally, with a coat of paint the grille is as good a new!
