24 June 2021

# A Tale of Two Hubcaps

by Haakon MacCallum  
member of Detroit Committee  
Vancouver Electric Vehicle Association

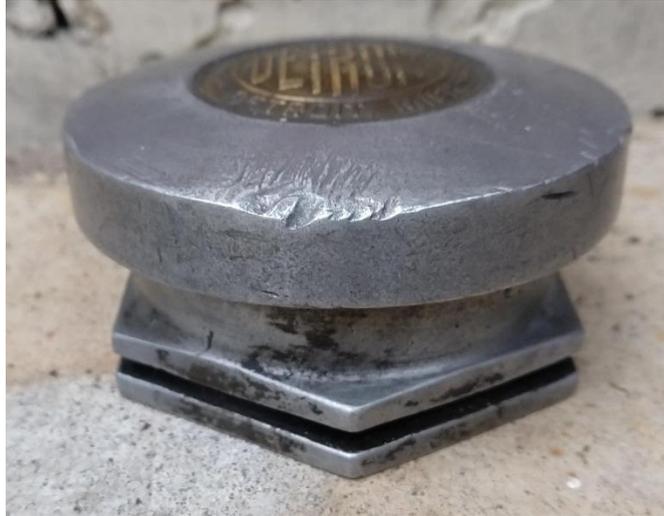
*Figure 6: A Real Detroit Hubcap*

The next problem to overcome was a missing hubcap. VEVA only had three. Again, it was time to pull out the Craigslist lathe and start turning.

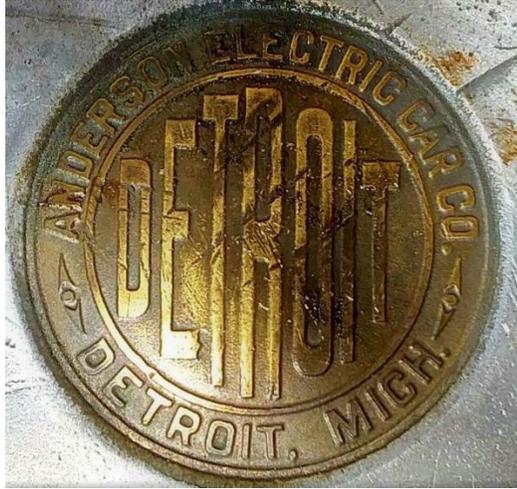
Figure 8: Original Hubcap Name Plate

Once the turning was done, the nameplate was next. A later version of the nameplate is shown nicely in drawing 35761 (many thanks to [electricvehiclemuseum.org](http://electricvehiclemuseum.org) and Galen Handy), though the ones on VEVA's car still have the Anderson Car Co. text. The nameplate was drawn in CAD and sent for manufacture. The original nameplate was likely stamped, but the replacement is made with CNC.
